M. Gontijo, C. Hoflehner, S. Ilie, J. Six & C. Sommitsch

Analysis of transverse corner cracks from continuous casting process and comparison to laboratory experiments

^aK1-MET GmbH, Linz, Austria; ^bInstitute of Materials Science, Joining and Forming, Graz University of Technology, Graz, Austria; ^cvoestalpine Stahl Linz GmbH, Linz, Austria

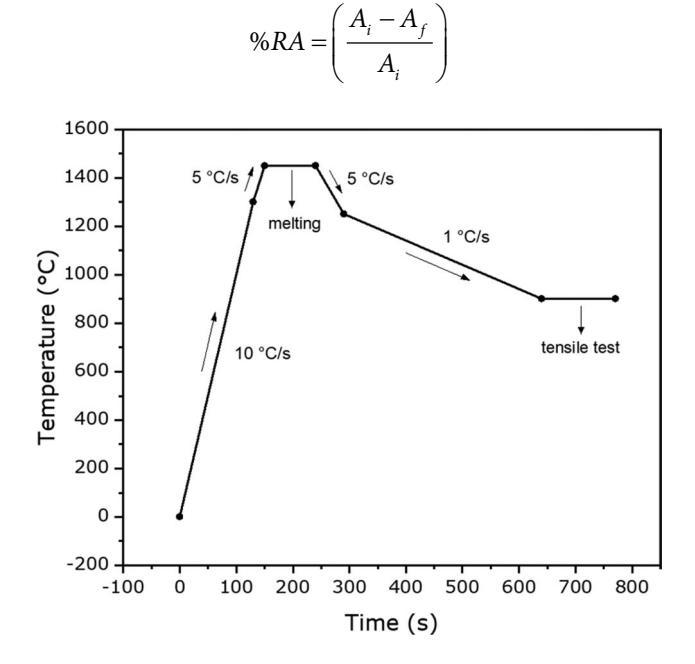
To replicate the industrial process as close as possible in the laboratory, the samples were heated until the melting point, with the temperature measured at the surface of approximately 1 440°C, held at this temperature for 60 s for dissolution of precipitates, and then controlled cooled until the desired test temperature, as shown in the thermal cycle presented in Figure 1.

Figure 1. Experimental thermal cycle used by Caliskanoglu (Caliskanoglu, 2015).

After reaching the test temperature, this was held for 10 s before each sample was pulled until fracture with a strain rate of 10^{-3} s^{-1} , usual for representing the deformation occurring during the industrial process. After rupture, the samples were quenched with pressurized air to freeze the microstructure at the point of failure.

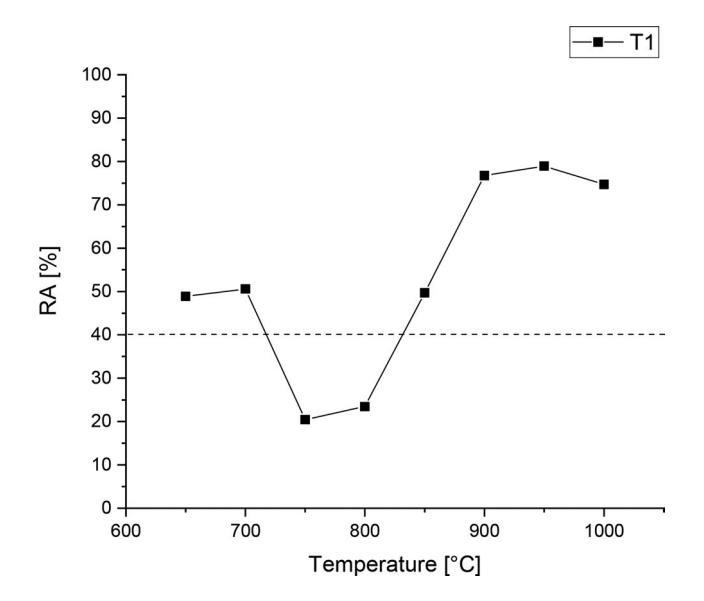
With the calculated RA values, the hot ductility curve of the material tested in the laboratory was defined and the ductility trough was identified to be between 700 and 850°C, with its minimum at 750°C, as shown in Figure 2 (Caliskanoglu, 2015). Two samples were chosen for the comparisons, one was tested at 750°C and the other at 950°C. The one tested at 750°C was chosen because of its lower ductility, which is the parameter used as an indicator of a tendency for crack initiation during the continuous casting process. The second one tested at 950°C is shown for exemplifying the contrast between the structures when the ductility is improved.

Figure 2. Hot ductility curve for the steel tested in the laboratory (Caliskanoglu, 2015).

The difference in the fracture type when the ductility is better can be seen in the images of the sample tested at 950°C shown in Figure 3b. In these images there are no distinct grains, and clear signs of ductile fracture are present, which are due to the better ductility reported at this temperature, shown in Figure 2. In this condition, it is less likely that a crack will initiate when the bending and straightening operations are applied to the slab produced. The absence of such features in the transverse corner crack samples is also an indication of correspondence between the conditions simulated in the laboratory and those of the industrial process.

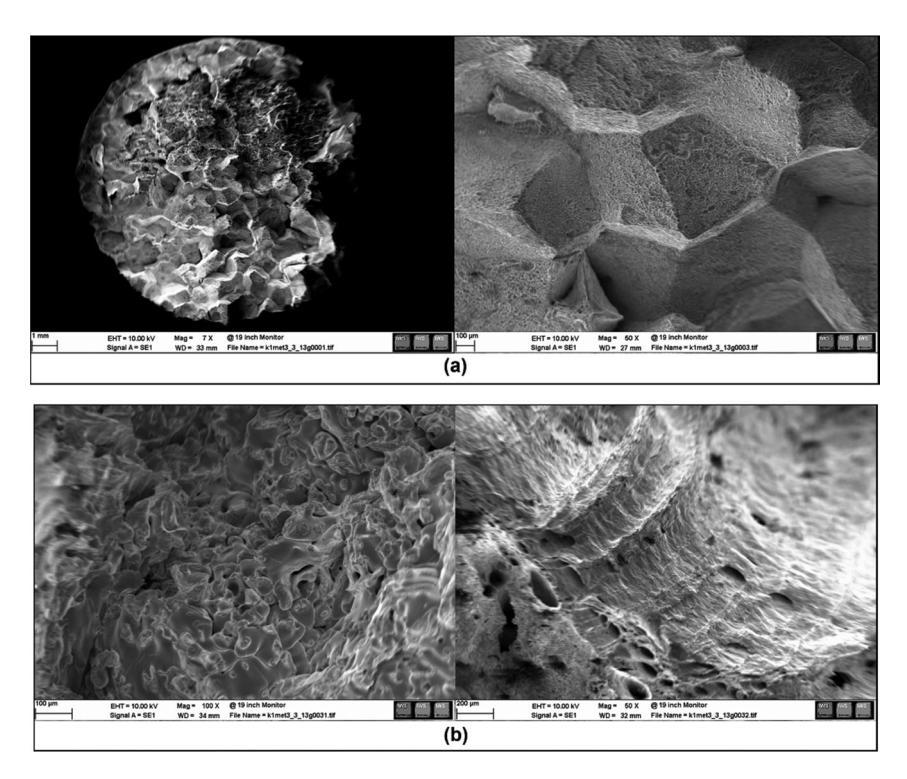
The images of the fracture surface of the samples tested in the laboratory at both chosen temperatures taken with SEM by Caliskanoglu (Caliskanoglu, 2015) are shown in Figure 3a and 3b. The images of the sample tested at 750°C show that a clear intergranular fracture took place, which is the typical behavior when a lower ductility is observed. The opposite is seen in Figure 3b, taken from the sample tested at 950°C, which presented a better ductility. In this, a dendritic structure is present in the center, together with a transgranular fracture and a plastic deformation.

Figure 3. SEM images of the fracture surfaces of the samples from the tensile tests at (a) 750 and (b) $950 \degree$ C (Caliskanoglu, 2015).

When comparing the images and the structures presented in the previous section, similarities can be identified between the samples tested in the laboratory and those from the continuous casting process. The brittle fracture seen in Figure 3 for the critical temperature of 750°C, characterized by the propagation of cracks along the grain boundaries, can be seen with the clear identification of grain surfaces. These features can be compared to the samples (a) and (b) shown in Figure 4, from the cast slabs, which also present clear grain surfaces. Brittle fractures are associated with the lower ductility of the steels, and it can be therefore concluded that the appearance of cracks in the slab corners, represented by the samples in Figure 4, are due to a low ductility at the moment and the temperature when stresses were applied to the slab. This corresponds to the low ductility and brittle fracture reported for the sample tested in the laboratory at 750°C. The equivalence between what is seen in the samples from the industrial process and the samples tested in the laboratory that showed a critical behavior shows that the samples tested using the experimental method presented can reproduce the structure seen in the failed specimens from the continuous casting process.

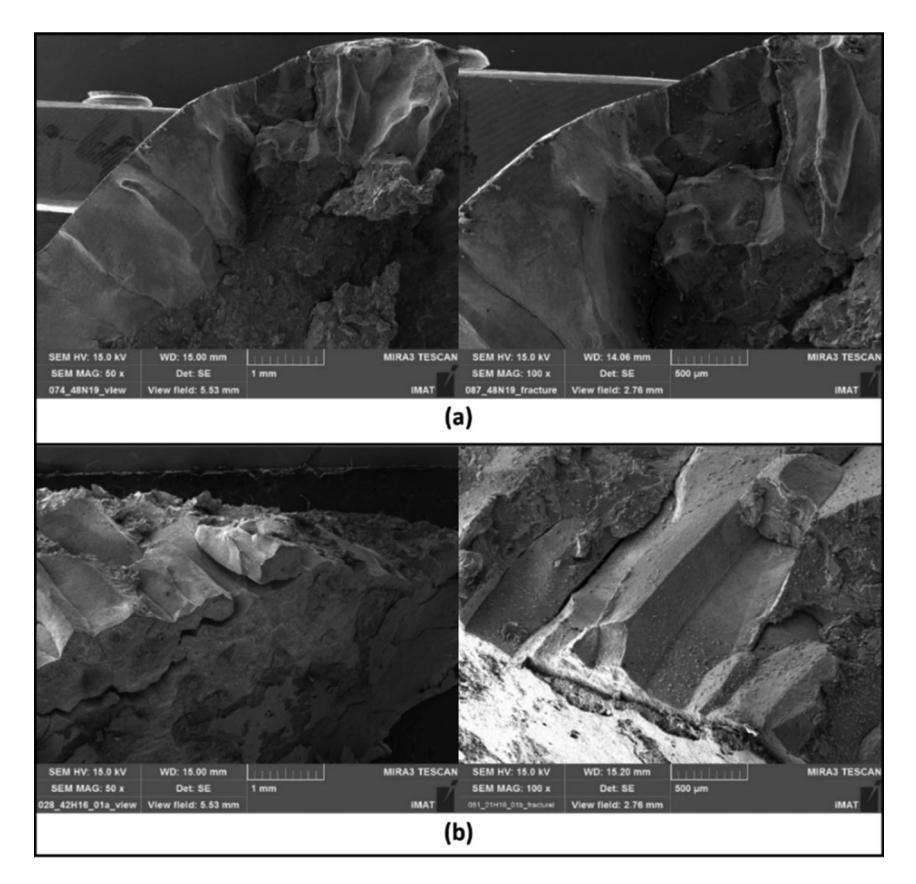
The samples taken from the cast slabs, C1 and C2, where transverse corner cracks were identified, were also observed with SEM for analysis of the fracture structure after the exposure of the crack and the images are shown in Figure 4a and 4b. The images present an intergranular type of fracture, with clear grain surfaces. This indicates a brittle behavior of the material, that caused the initiation and growth of the cracks in the steel slab.

Figure 4. SEM images of the fracture surfaces of the samples from two different continuous cast slabs, (a) C1 and (b) C2.

boundaries revealed are very thin and light, therefore they and the cracks formed were highlighted for easier identification (in blue the grain boundaries and in red the cracks). This reiterates the brittle fracture identified in the SEM images from Figure 4.

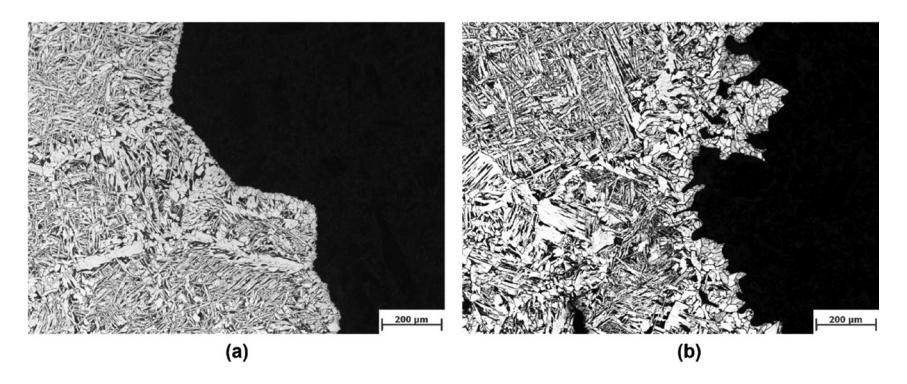
could be observed using a light optical microscope (LOM). The results are shown in Figure 5a and 5b for the samples from the hot tensile tests and in Figure 6a and 6b for the samples from the cast slabs. In Figure 5a, from the sample tested at 750°C with lower ductility, it is possible to see that the fracture followed the prior austenite grain boundaries, where ferrite films were also present. Figure 5b shows the difference when a better ductility is seen, which was the case for the sample tested at 950°C. No clear fracture along grain boundaries was present and an elongation of the structure was noted.

Figure 5. LOM images of the microstructure of the samples from two hot tensile test conditions (T1), (a) 750 °C and (b) 950 °C.

Observing the microstructure of the images from Figures 5 and 6, the results can be compared once again. The samples tested in the laboratory can be quenched at the point where the cracks were originated, making it possible to analyze the microstructure at the point that led to the failure, what is not the case for the industrial samples. In the industrial process, it is difficult to detect the exact point of failure since the microstructure changes significantly during the slow cooling path of the continuous casting. That implies in different etching methods necessary for laboratory or industrial samples to reveal well the different microstructures, as shown in the figures, especially the prior austenite grain boundaries, which are areas of interest regarding the growth of cracks.

Figure 5a shows that the cracks are originated and propagate along the prior austenite grain boundaries at 750°C, where ferrite films are

also present. In the case of the sample tested at 950°C, which showed a much better ductility, the fracture clearly does not follow grain boundaries and the structure is elongated at the edge, indicating that it could withstand more strain before failure.

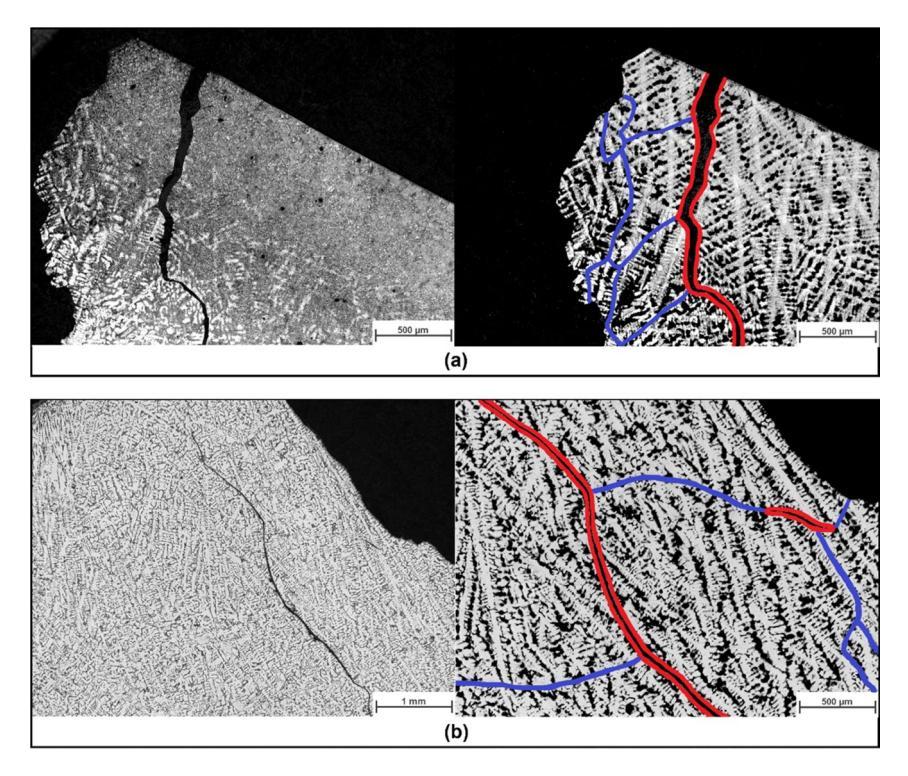
In the Figure 6a and 6b photographs of the microstructure of the samples from the slab corners shows the initiation and growth of the cracks along the prior austenite grain boundaries. The different etching method had to be used in this case to reveal the prior austenite grain boundaries due to the dendritic microstructure formed in the solidified shell during the slower cooling of the industrial process. The grain

Figure 6. LOM images of the microstructure of the samples from the cast slabs etched with Nital (left side image) and with modified Bechet-Beaujard etchant (right side image), (a) C1 and (b) C2.

To be able to compare the structure observed in the samples from the steel slabs to the samples from the experiments, a second etching method had to be used for revealing the prior austenite grain boundaries, since the dendritic structure formed in the solidifying shell of the slab does not respond the same to the method used for the tensile test samples. Therefore, after etching with the modified Bechet-Beaujard etchant, the structure shown in Figure 6a and 6b can be compared to the results mentioned from the sample tested at 750°C, with lower ductility. In these samples, a propagation of cracks along the prior austenite grain boundaries, that could be revealed with the adequate etchant, was clearly seen, very similar to the samples from the laboratory test that showed the lowest ductility.
